**Update Phase I Environmental Site Assessment Report  
for the Property Located at  
1160 Allene Avenue in  
Atlanta, Georgia**

**The Trust for Public Land  
One Georgia Center  
600 West Peachtree Street  
Suite 1840  
Atlanta, Georgia 30308**

**February 15, 2009**

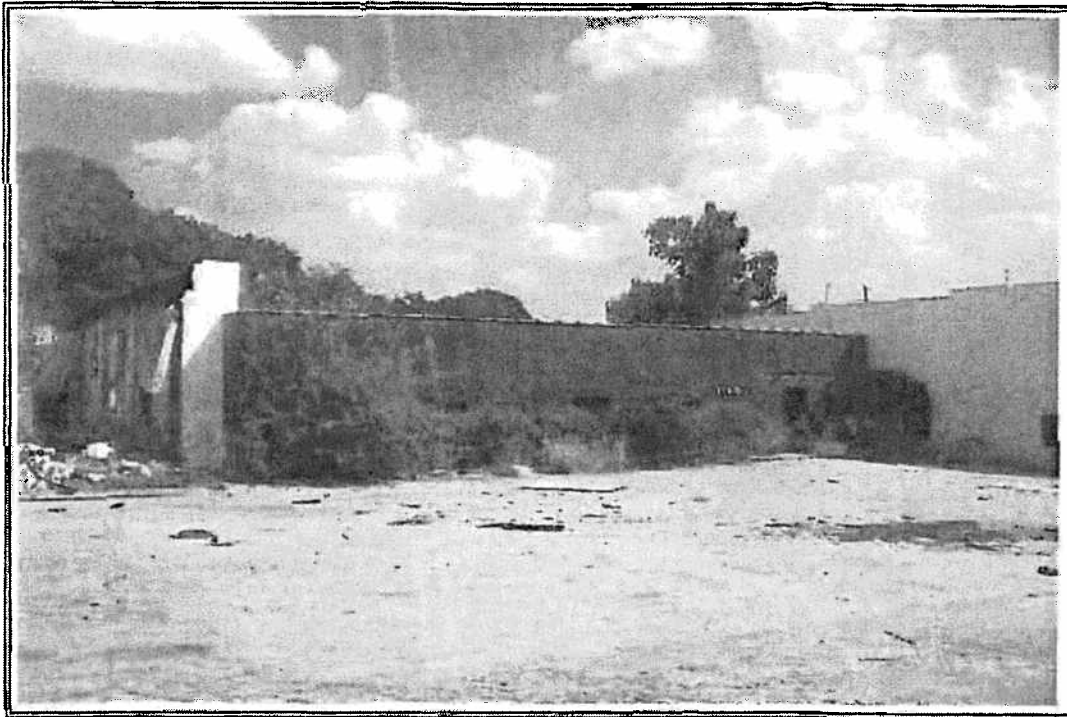
View of Former Office for Harmon Brothers

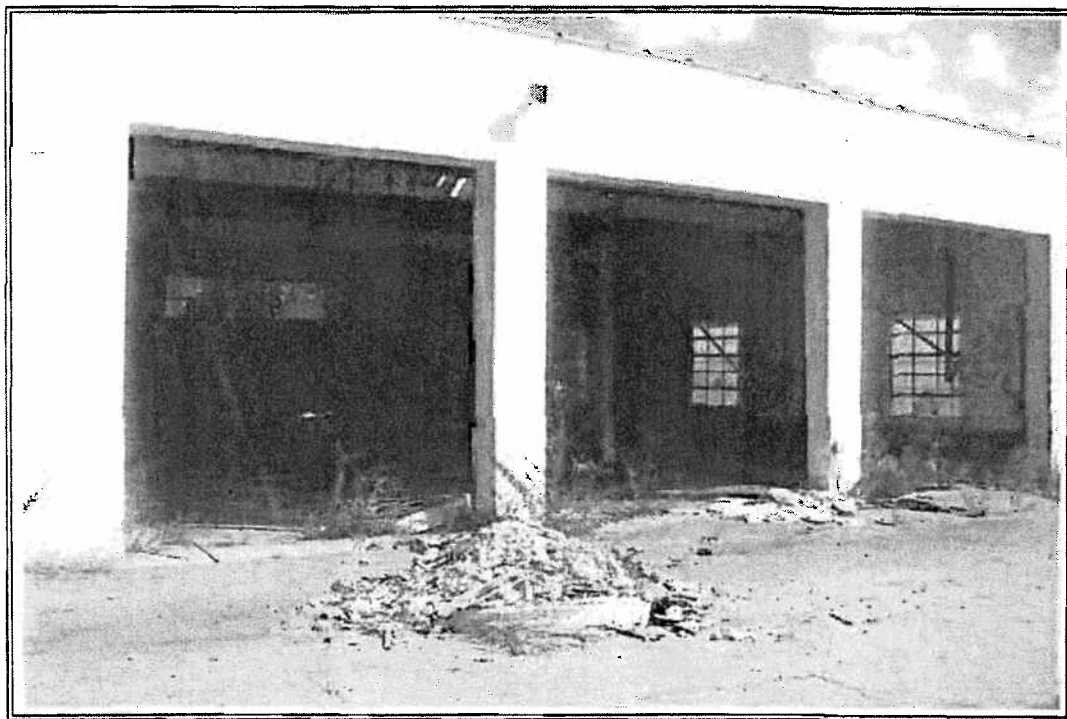
Two service garage buildings are located north of the office area. Both of the buildings are in poor condition. The northern most building is a concrete block structure with one service bay and a flat roof with wood trusses and wood decking. The second building is connected to the northern side of the office building. This is a concrete block structure constructed on a concrete slab with a flat roof. This building has two service bays and one of the service bays has a pit.

View of Bus and Truck Service Garage

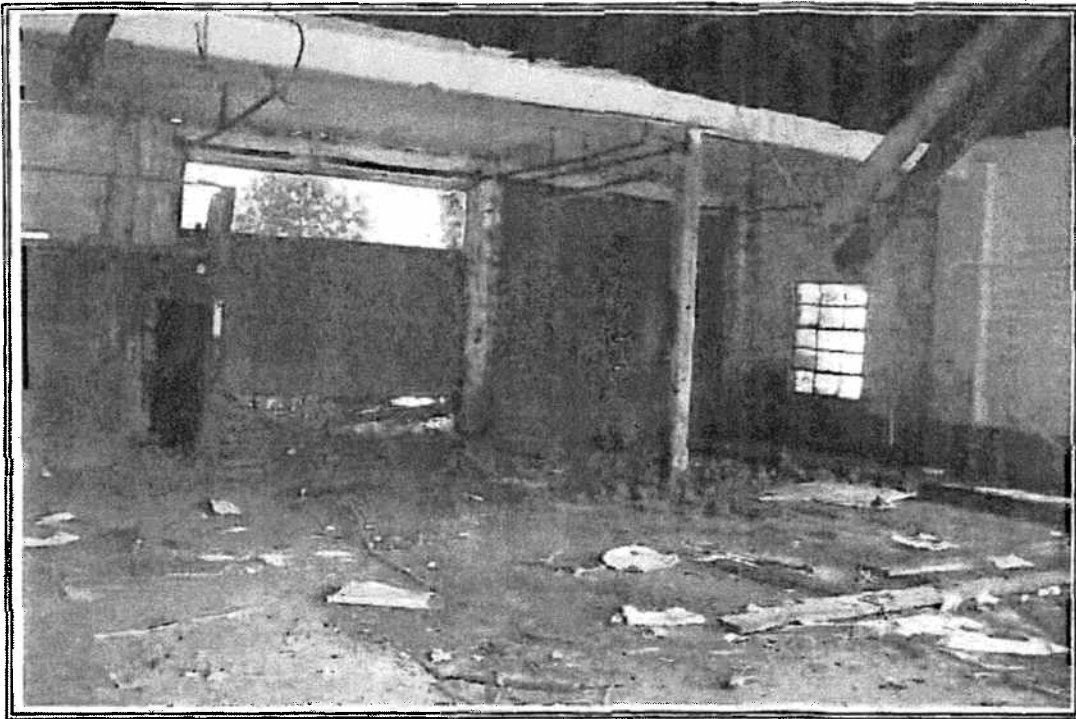
View Inside of Former Bus/Truck Service Garage

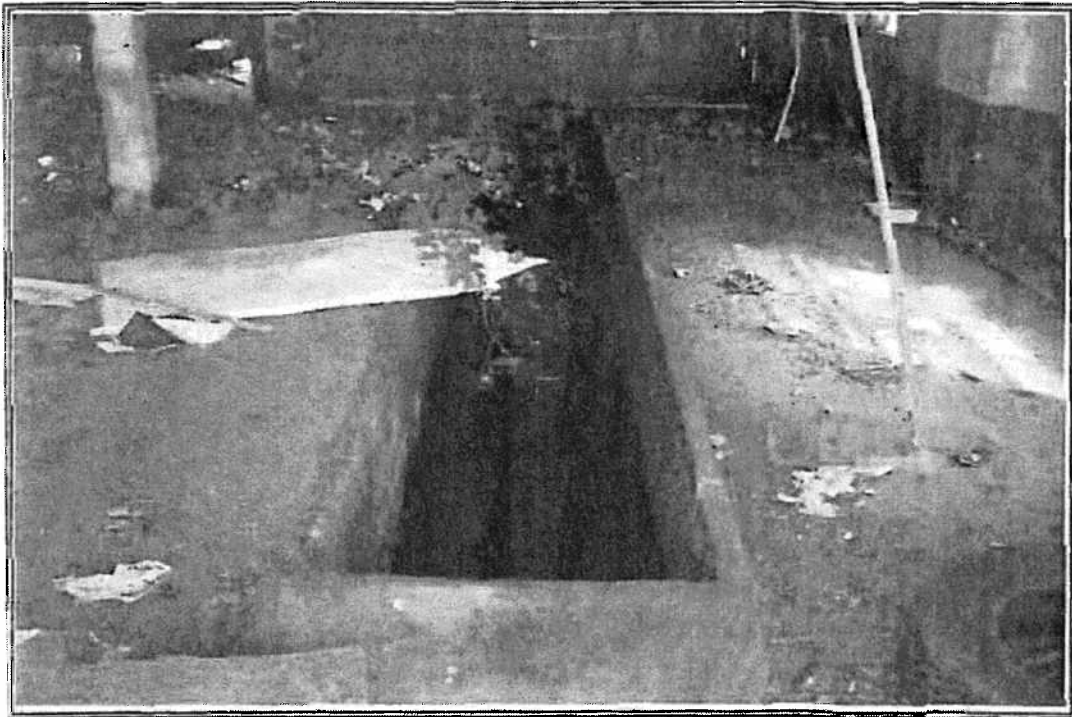
Pit Located in Service Bay

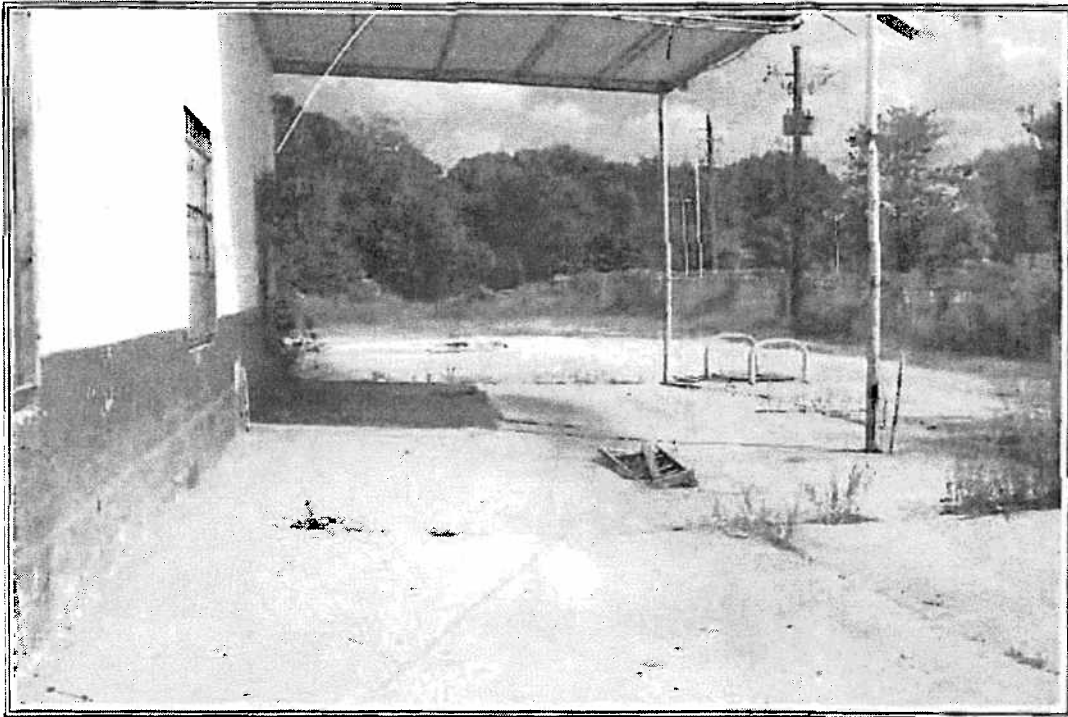
Covered Service Bay Area Adjacent to South Side of Building

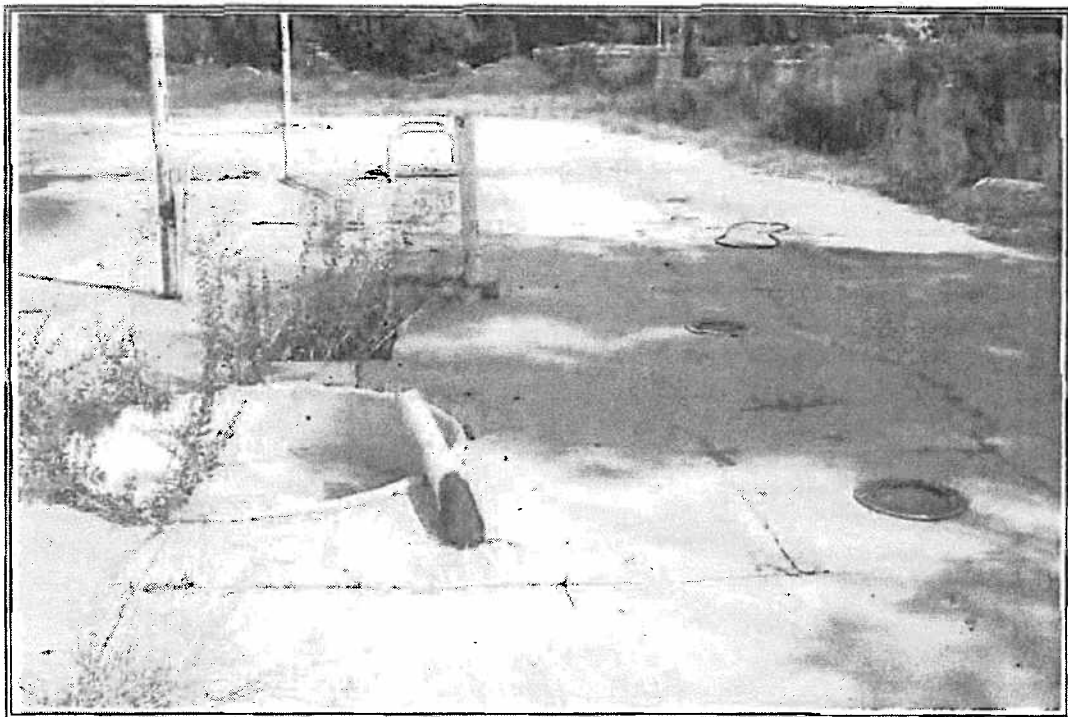
A 10,000-gallon double walled, cathodically protected underground storage tank is used to store diesel fuel. The UST and dispenser are located on the southern side of the property. A large area of petroleum stained soil was noted in the area of the fuel dispenser. Other areas of petroleum stained soil was noted on the southeast side of the property. Three tanks that were formerly used to store diesel and gasoline were removed in 1998.

Several areas were identified where petroleum product releases have occurred. The largest and most obvious area of spills is evident in the area of the diesel fuel dispenser. Stained soil is located around the dispenser and has also migrated to a low lying area east-southeast of the dispenser. Other areas of petroleum stained soil were noted on the southeast and southwest sides of the property where containers of oil have been stored or servicing of vehicles has been conducted. In 2006, investigations were completed by ETRI and Mactec to delineate the extent of soil contamination in this area of the Site.

View of Diesel Underground Storage Tank Located on South Side of Property

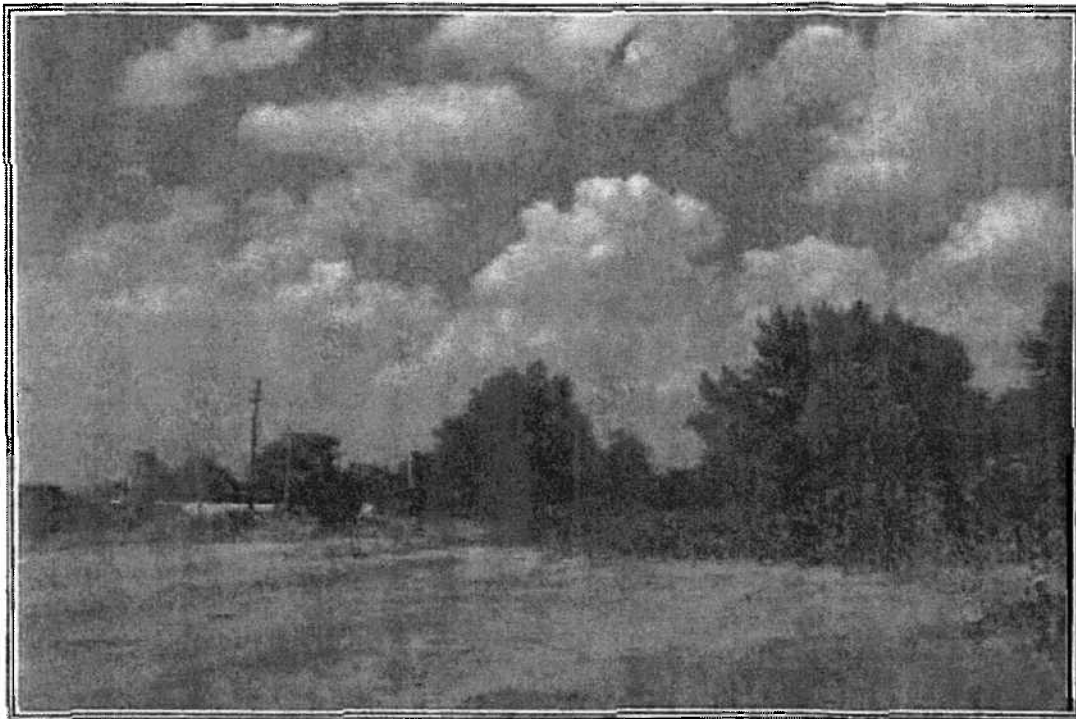
View of Northern Side of Property

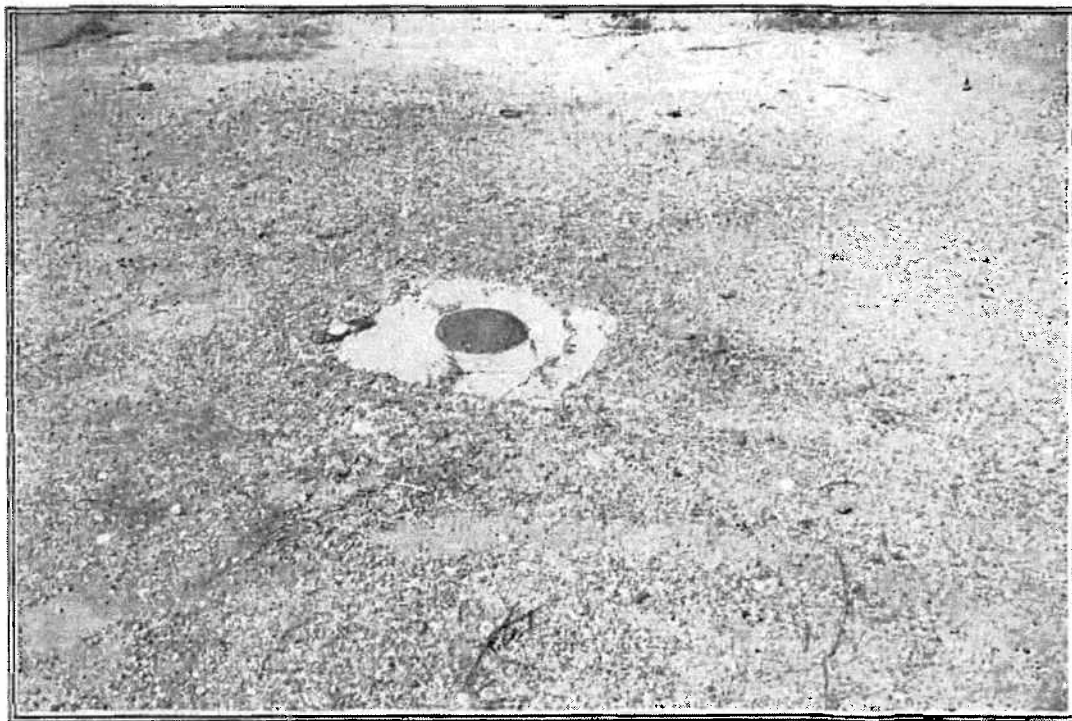
- Existing groundwater monitoring wells from the investigations completed as part of the tank closure were sampled for volatile organic compounds. The results of the analyses determined that groundwater in one of the monitoring wells contain Cyclohexane, Isopropylbenzene and Methylcyclohexane. Groundwater in another monitoring well was found to contain Chloroform. Previous findings from groundwater testing were reported to the Georgia EPD. The presence of Isopropylbenzene in groundwater, which was previously not detected, may require reporting to the Georgia EPD. Petroleum products are exempt from reporting under the Hazardous Sites Response Act (HSRA). Isopropylbenzene originates from petroleum refining and is likely a constituent in petroleum fuels.

Groundwater Monitoring Well Located on North Side of Property
